**Flood Control Project Maintenance
Levee Inspections**

Maintenance Issue Types Only, Levee Inspection Report By Mile - Spring 2015

Reclamation District No. 2091 Chase

Waterway	Bank	Unit Miles	Inspection Start/End	Inspector
Unit No. 01 San Joaquin River	Right	7.46	05/26/2015 05/26/2015	Richard Willoughby

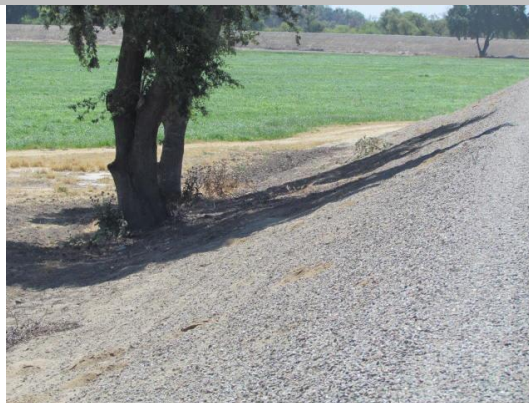
Photo 1 of 1 : SP_2015_RD2091_318_12_20150527_00009.jpg

LM Start	0.00	Rating **	A	Issue No.	12
LM End	7.45	Issue Type +	Ma	Location *	LS
Category	Earthen Levee			GPS Latitude/Longitude	
				Start	End
Item	Vegetation				o
					o
DWR ID	DWR_RD2091_01_s_2015_12				
Action/Comments					
Control annual grass and weeds on the levee slopes and easements.

Looking at typical view of landward slope.

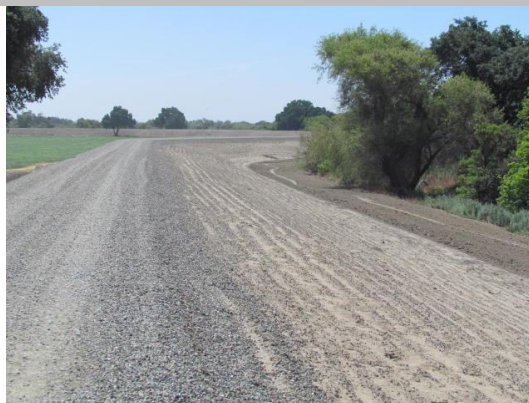
Photo 1 of 1 : SP_2015_RD2091_318_13_20150527_00010.jpg

LM Start	0.00	Rating **	A	Issue No.	13		
LM End	7.45	Issue Type +	Ma	Location *	WS		
Category	Earthen Levee			GPS Latitude/Longitude			
				Start	End		
Item	Vegetation				o		o
					o		o
DWR ID	DWR_RD2091_01_s_2015_13						
Action/Comments							
Control annual grass and weeds on the levee slopes and easements.

Looking south at typical view of waterward slope.

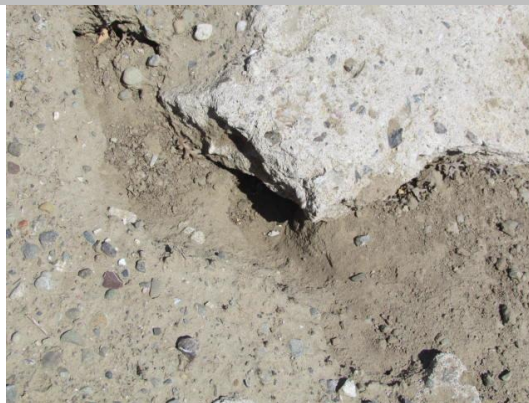
Photo 1 of 1 : SP_2015_RD2091_318_11_20150527_00008.jpg

LM Start	5.66	Rating **	M	Issue No.	11
LM End	5.68	Issue Type +	Ma	Location *	LS
Category	Earthen Levee			GPS Latitude/Longitude	
				Start	End
Item	Animal Control			37.486090 °	37.485839 °
				-121.067612 °	-121.067357 °
DWR ID	DWR_RD2091_01_s _ 2015_11				
Action/Comments					
No rodents visible, but rodent burrows visible; need to backfill and compact or grout burrows.					
Inspector Comments: Several rodent holes noted at the base of the tree on the landward toe.

Looking at typical view of rodent holes on the landward slope and toe.

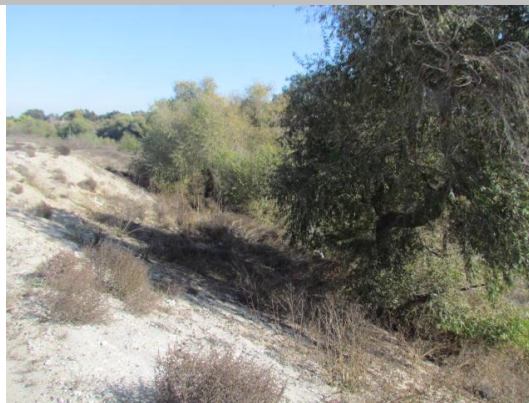
Photo 1 of 2 : SP_2015_RD2091_319_1_20150309_00001.jpg

LM Start	0.03	Rating **	M	Issue No.	1
LM End	0.03	Issue Type +	Ma	Location *	WS
Category	Earthen Levee			GPS Latitude/Longitude	
				Start	End
Item	Trim / Thin Trees			37.482523 °	37.482523 °
				-121.051103 °	-121.051103 °
DWR ID	DWR_RD2091_02_s_2012_1				
Action/Comments					
Thin trees to allow visibility of the ground and room to flood fight.

Looking east at untrimmed trees on waterward slope. (Fall 2014)

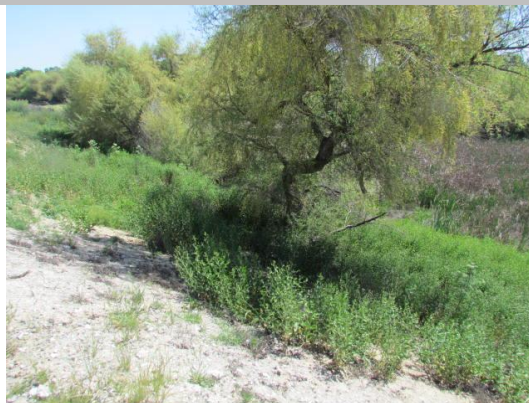
Photo 2 of 2 : SP_2015_RD2091_319_1_20150309_00002.jpg

Looking east at untrimmed tree on waterward slope. (Spring 2014)

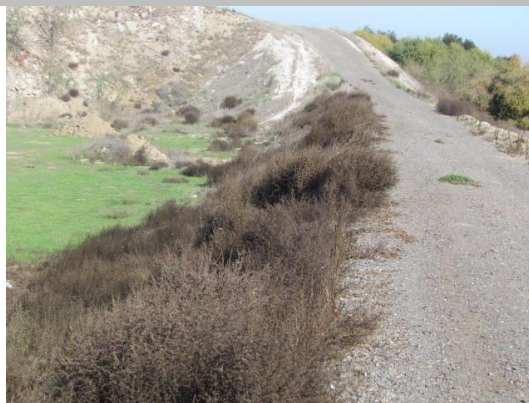
Photo 1 of 1 : SP_2015_RD2091_319_2_20150309_00003.jpg

LM Start	0.05	Rating **	M	Issue No.	2
LM End	0.10	Issue Type +	Ma	Location *	LS
Category	Earthen Levee			GPS Latitude/Longitude	
				Start	End
Item	Vegetation			37.482815 °	37.483306 °
				-121.050849 °	-121.050302 °
DWR ID	DWR_RD2091_02_f_2012_2				
Action/Comments					
Remove the wild growth other than native grasses from the levee slopes.					
Inspector Comments: Control tumble weeds on landward slope.

Looking north at tumble weeds on landward slope.

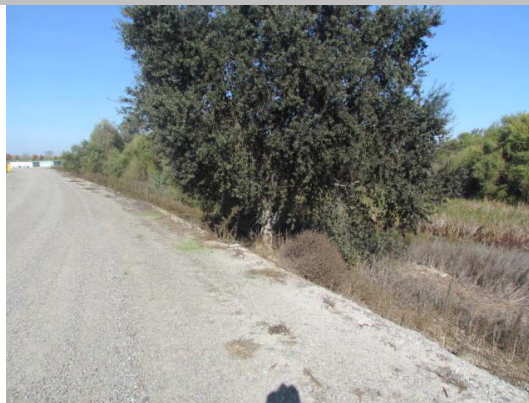
Photo 1 of 1 : SP_2015_RD2091_319_3_20150309_00004.jpg

LM Start	0.18	Rating **	M	Issue No.	3
LM End	0.18	Issue Type +	Ma	Location *	WS
Category	Earthen Levee			GPS Latitude/Longitude	
				Start	End
Item	Trim / Thin Trees			37.484342 °	37.484342 °
				-121.049848 °	-121.049848 °
DWR ID	DWR_RD2091_02_f_2012_3				
Action/Comments					
Trim trees to at least five feet above ground level.

Looking north at untrimmed tree on waterward slope.

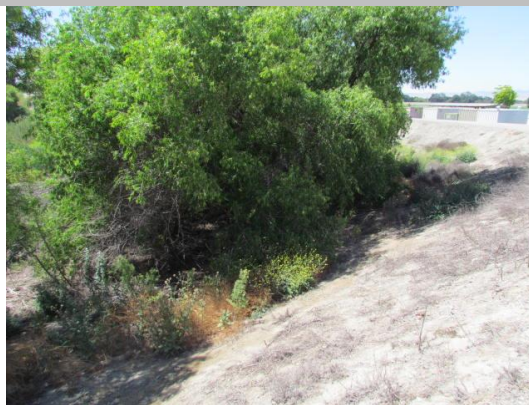
Photo 1 of 1 : SP_2015_RD2091_319_14_20150527_00013.jpg

LM Start	0.23	Rating **	M	Issue No.	14
LM End	0.27	Issue Type +	Ma	Location *	WS
Category	Earthen Levee			GPS Latitude/Longitude	
				Start	End
Item	Trim / Thin Trees			37.484917 °	37.485418 °
				-121.050224 °	-121.049933 °
DWR ID	DWR_RD2091_02_s_2014_14				
Action/Comments					
Trim trees to at least five feet above ground level. Inspector Comments: Control trees on waterward slope.

Looking northeast at untrimmed tree on waterward slope.

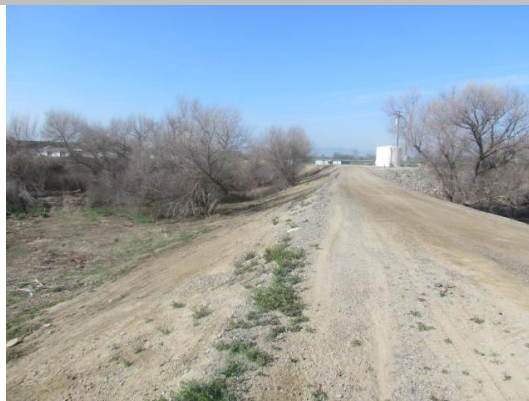
Photo 1 of 1 : SP_2015_RD2091_319_4_20150309_00005.jpg

LM Start	0.28	Rating **	M	Issue No.	4
LM End	0.28	Issue Type +	Ma	Location *	LS
Category	Earthen Levee			GPS Latitude/Longitude	
				Start	End
Item	Trim / Thin Trees			37.485447 °	37.485447 °
				-121.049750 °	-121.049750 °
DWR ID	DWR_RD2091_02_f_2012_4				
Action/Comments					
Trim trees to at least five feet above ground level.

Looking east at trimmed trees on landside slope and toe.
